INSPECTION REPORT PREPURCHASE

PROPERTY LOCATED AT
13, Model
Lorraine, (Québec) VVV YYY

File: GIP24012015/02

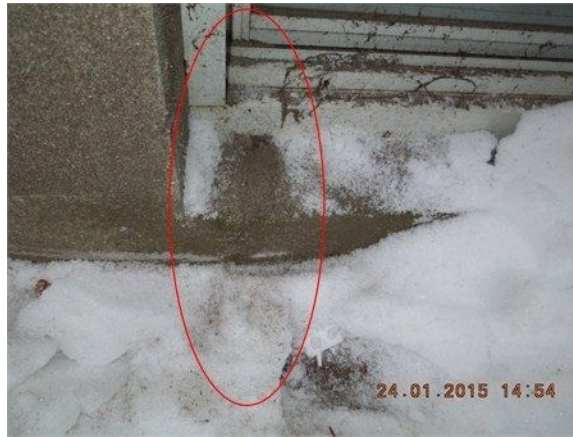
right side

We note minor fissures along the foundation wall. These fissures may represent water infiltration, and should be plugged to avoid water infiltration into the basement. It is suggested that repairs of these fissures be done from the outside for, if the foundation were to shift slightly, only the exterior membrane would follow the movement, while remaining waterproof. It is preferable to use urethane-based products for the injection. In contrast with epoxy, urethane retains its relative elasticity and thereby its capability to maintain waterproofness of the fissure. For these repairs, we recommend that you employ a specialist capable of providing a guarantee for his work.

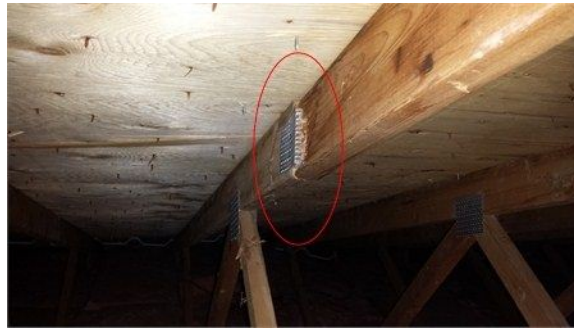
signs of penetration

During our inspection, we noticed the weakness of one rafter, we advice you to consult a carpenter to reinforce this part in order to avoid damage in the roof structure.

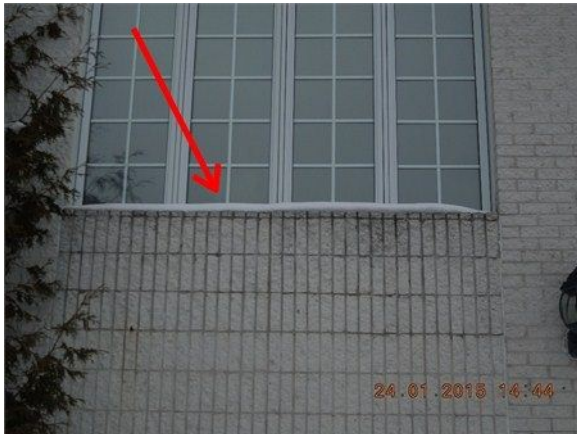
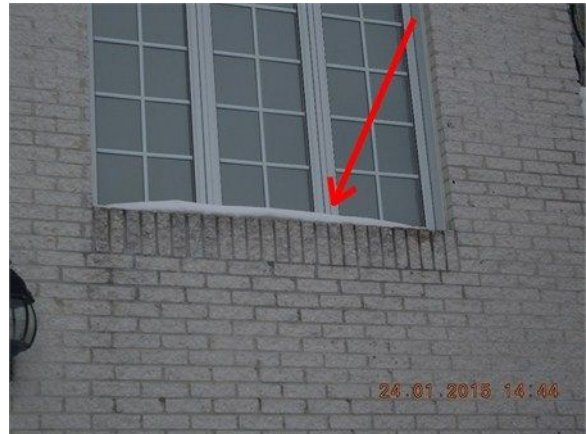
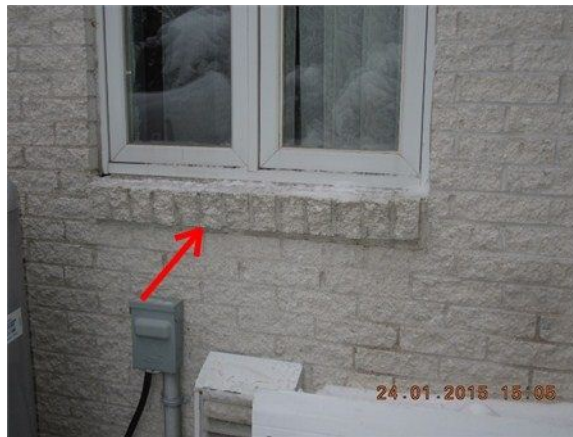
The window sills are made of brick masonry units. The masonry joints are not designed to be installed horizontally because they absorb water and deteriorate with the freezing and thawing cycles. Afterwards, water leaks into the wall under the window and damages the internal components. The joint's watertightness also often tends to be precarious. We recommend this situation be corrected to prevent water from deteriorating the mortar. Replace the window sills with stone sills or, install an aluminium or enamelled steel sheet on the horizontal surface with a drip at the end. You can also steadily maintain the mortar joints and regularly apply a good quality silicone-based concrete waterproof treatment to the surface of the sills.

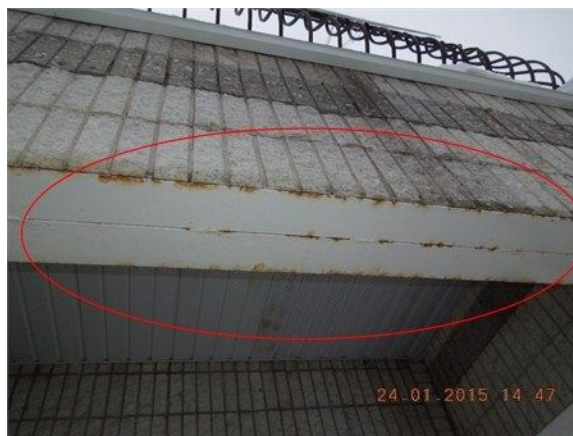
main entrance

A lintel is designed to divide a load on either side of an opening. They are made of steel. Regular maintenance is required to avoid the spreading of rust.

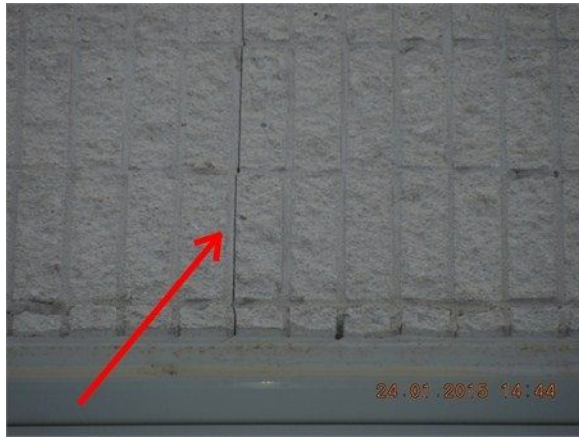
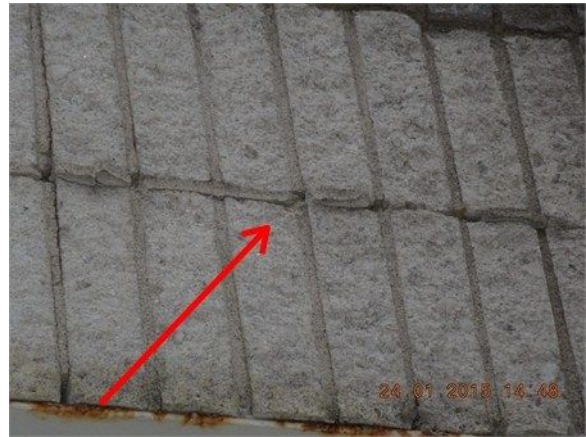
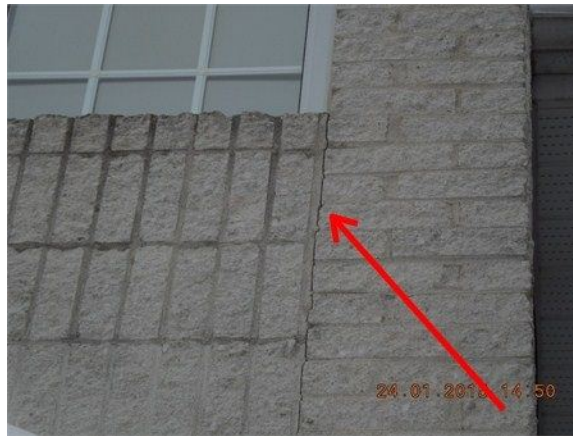
The mortar joints are deteriorated in some places. The mortar found between the masonry elements (on the facades and in the sections which are the most exposed to bad weather) is sensitive to water infiltration and, with the freezing and thawing cycles, crumbles with time. We recommend particular attention be paid to the situation and corrective measures be seen to without delay.

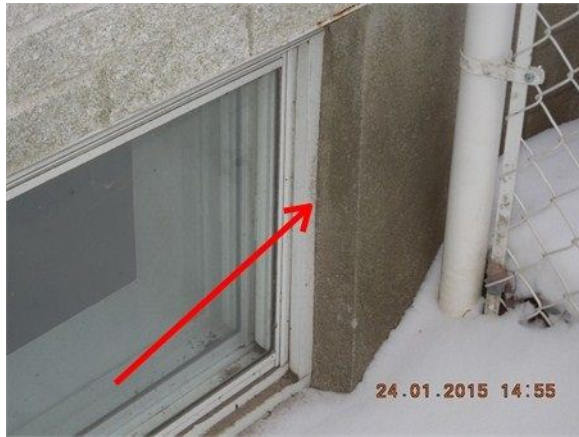
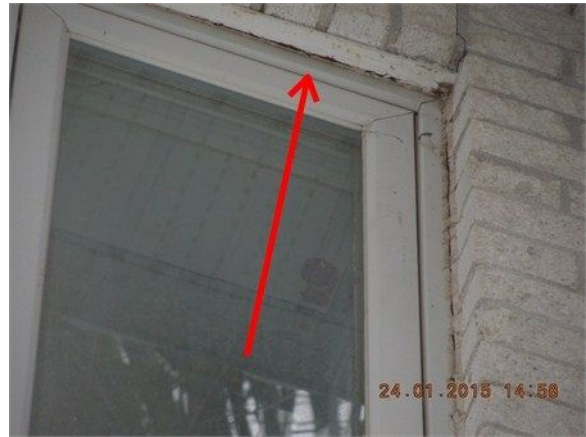
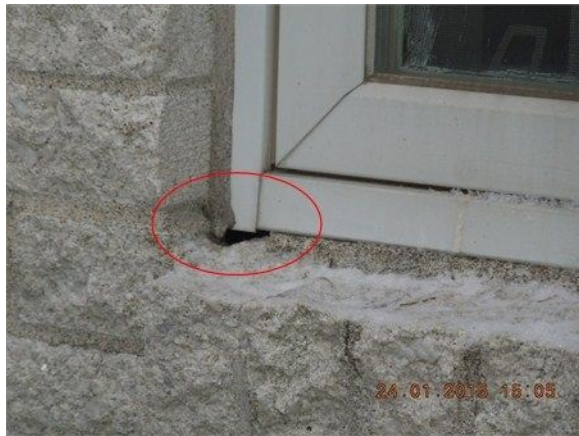
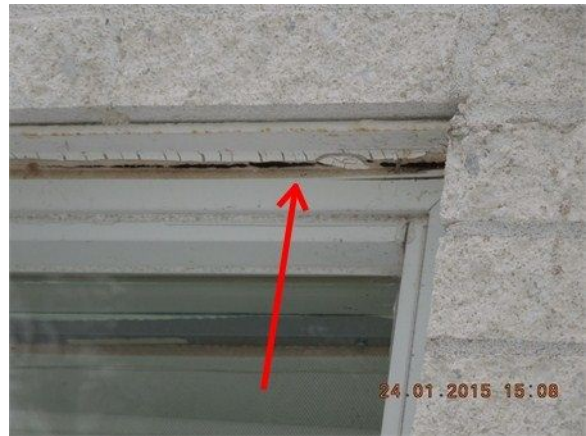
The sealant joints are deteriorated and will need to be redone on the entire building. We recommend you check the condition of the seals every year to prevent water infiltration within the building's envelope and the deterioration of internal components.

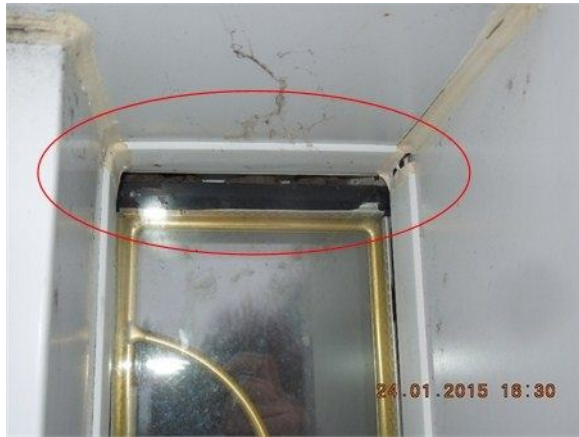
second floor balcony

During our inspection, we noticed a door needs reparation in order to avoid energy loss and the deterioration of the door

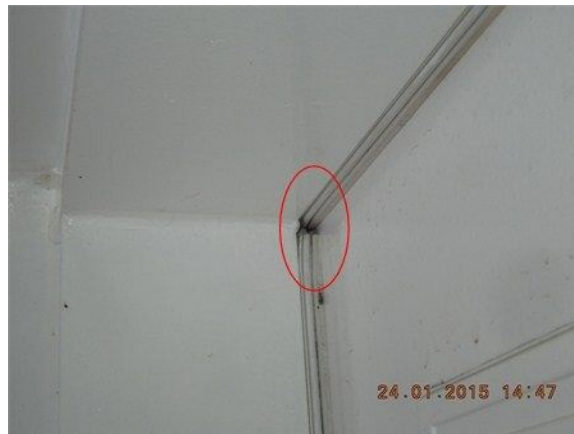
main door

We noted that the weatherstripping around one of the house's doors is either ineffective. As such, cold air enters the house, causing discomfort and increasing the energy consumption for wintertime heating. Replace with appropriate weatherstripping.

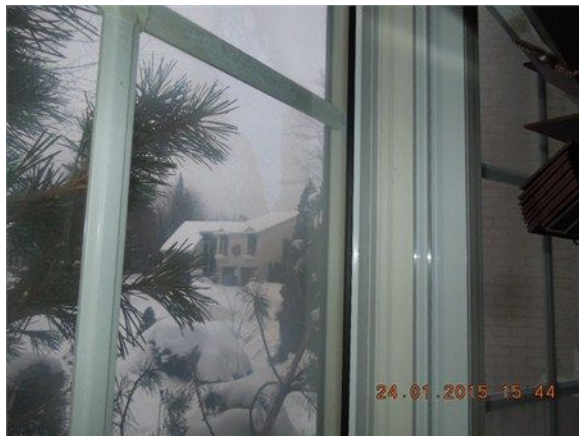
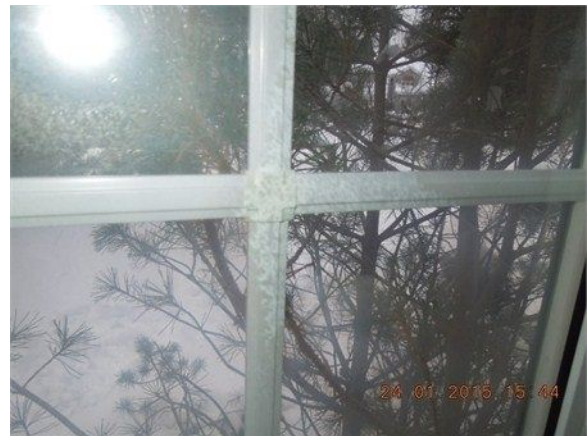
During our inspection we noticed condensation in a thermopane window (main facade) this can be probably the result of the thermalpane joints deterioration or the saturation of the silica beads that are inside the hollow bar between the two panes. Specialist advice is appropriate, it may be necessary to proceed to change the glass.

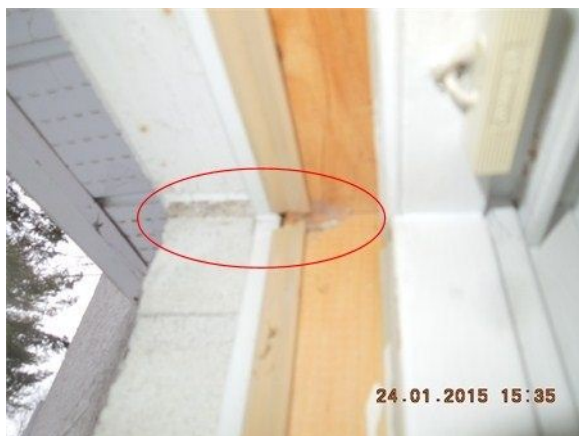
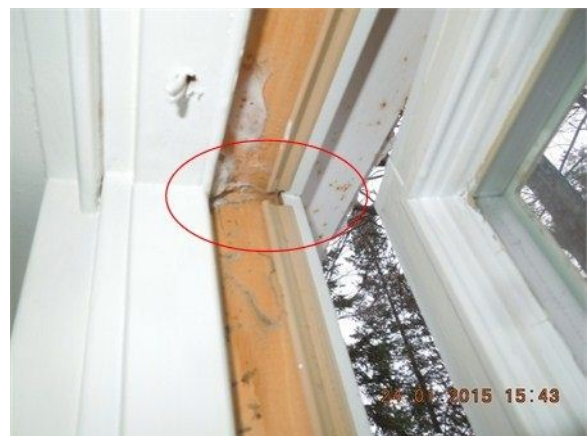
We note that the weather strip around one or more openings in the building is either ineffective. This allows cold air to penetrate into the interior, causing discomfort and increasing the energy consumption for wintertime heating. Appropriate weather strips should be installed.

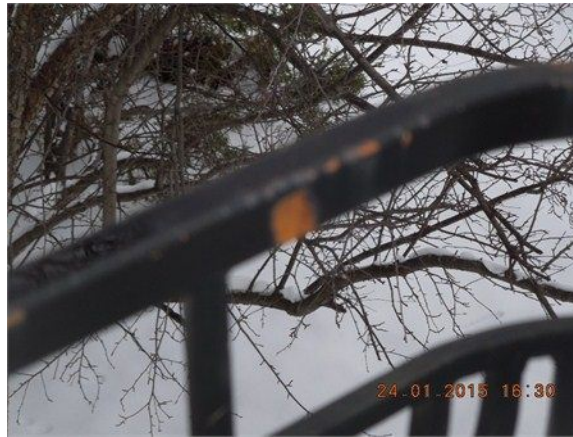
second floor

Keep the outside metal railing in good condition without nicks and well painted with a special waterproof paint to prevent complete deterioration of the component due to corrosion.

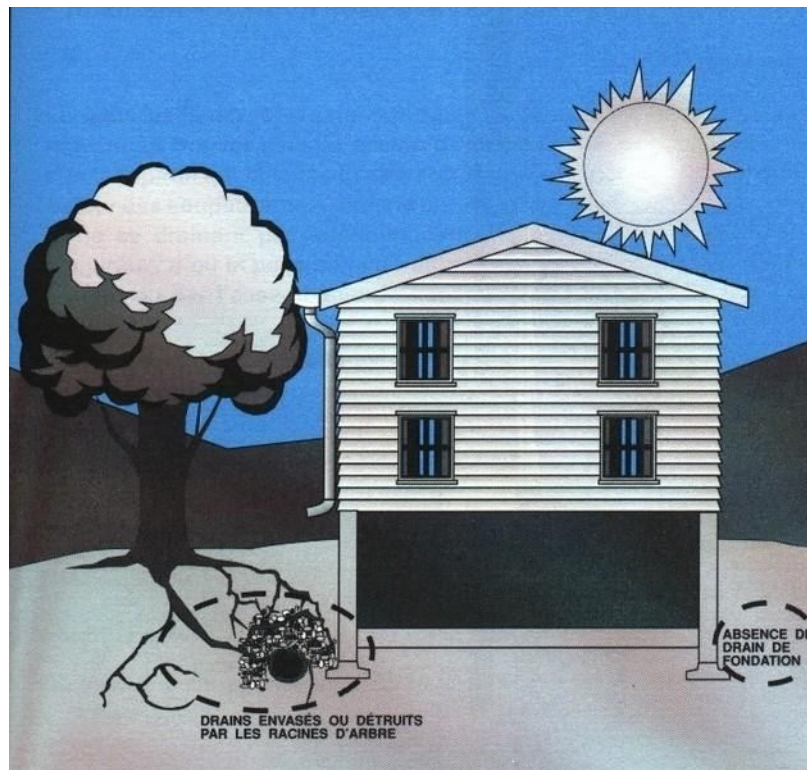
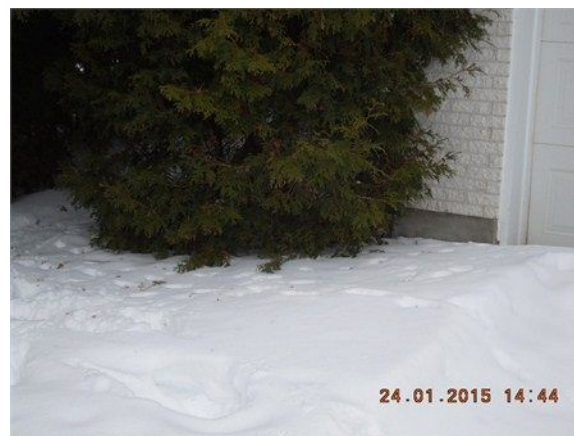
During our inspection, we noticed the presence of shrubs and vegetation within 6 feet of foundation walls. This situation could cause humidity excess in the basement, and problems for the foundation walls and drain system as well. Tree limbs touching buildings also provide easy access to the home for pests.

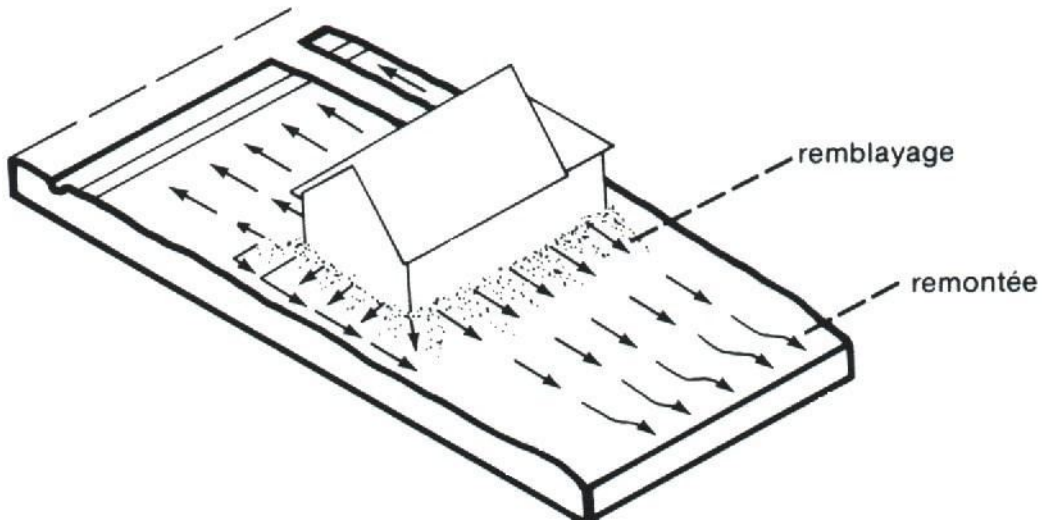
The slope of the land around the building is a very important factor in avoiding water infiltration and humidity problems in a basement. Due to the presence of snow, it is impossible for the inspector to evaluate the slope of the land. In the spring you must verify that the land slope is running away from the building in order to properly direct rain water and melting snow away from the building.

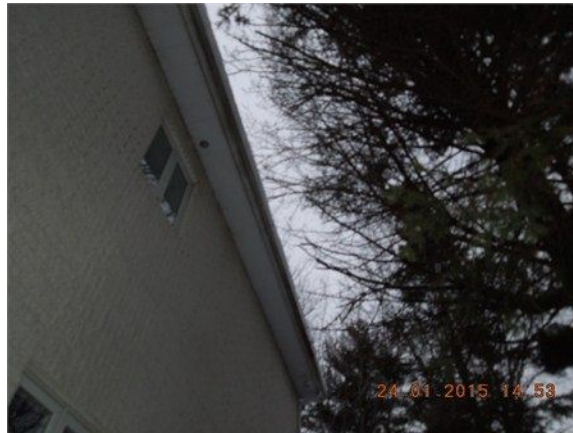
Trees should be kept trimmed away from roof and wall surfaces. The abrasive action of branches rubbing against the roof can damage the roof system. Tree limbs touching buildings also provide easy access to the home for pests.

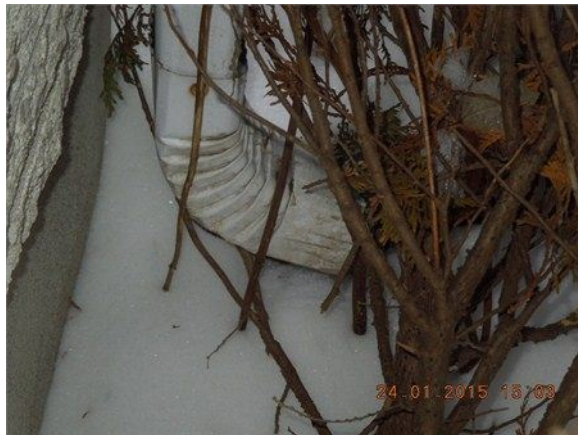
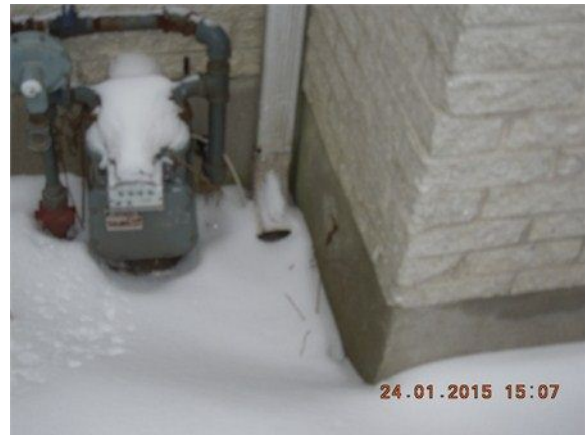
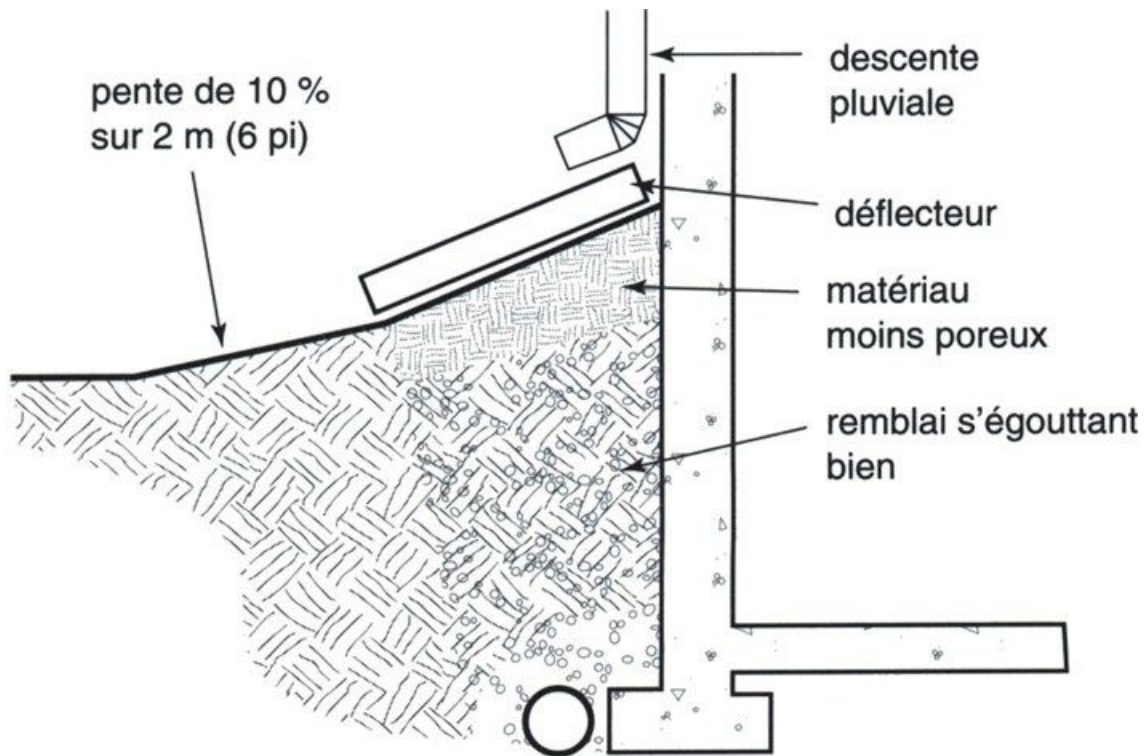
To avoid overloading the foundation drainage system, and to reduce the risk of water infiltration and excessive humidity in the basement, we recommend that downspouts direct water away from the house through the use of extensions or deflection slabs as needed. Leave 7 to 8 inches of space to avoid damage caused by winter ice and freezing. Eaves troughs should be inspected regularly (use a garden hose) and cleaned at least once each year (in the fall). If there are many trees in the area, it may be necessary to clean them more often.

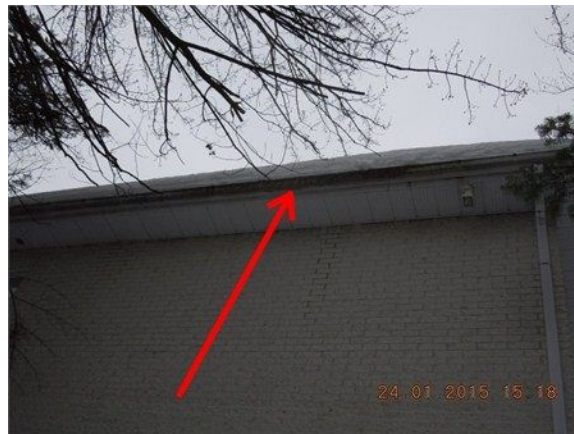
We note that the slope of the eaves troughs is reversed in some places. Water accumulates in these places, leading to plant growth and an accelerated deterioration of the component. We recommend that you consider correcting the slope or replacing the eaves troughs.

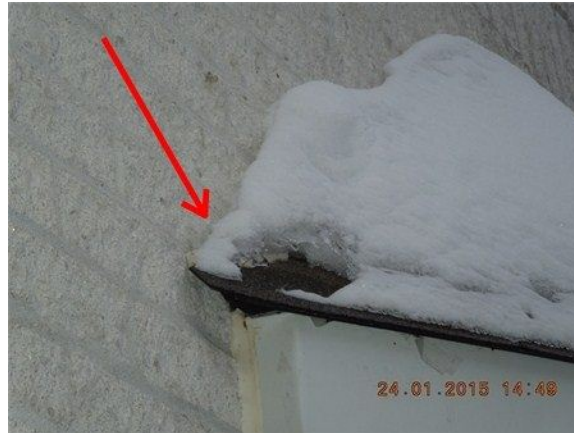
Main facade

We note that the flashings between the vertical wall and the roof covering were not installed in accordance with established norms. The seal should be checked regularly to avoid damage from water infiltration. Consult a building contractor to correct the situation, if required. When the roof will be reshingled, flashings should be installed in accordance with established norms. See illustration.

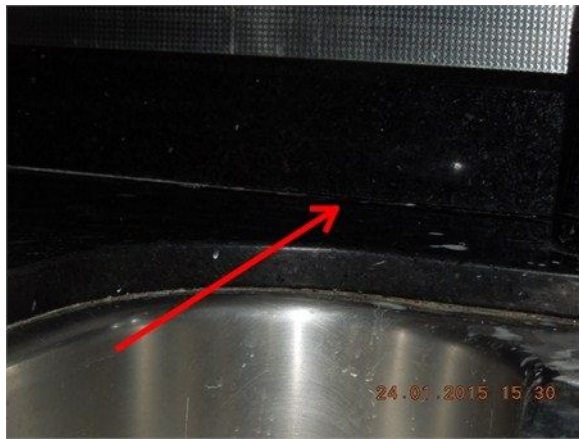
kitchen

The seal around the bath tub (and/or shower) and the sink should be kept in good condition to prevent water leaks into the adjacent wall. The absence of a waterproof seal could lead to serious damage to the wall, formation of moulds, and deterioration of the gyproc and/or wooden components.

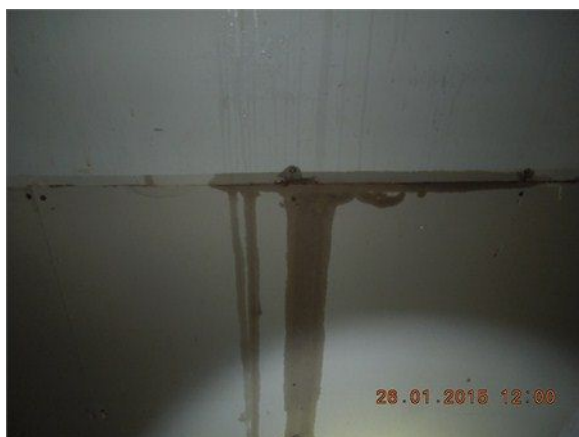
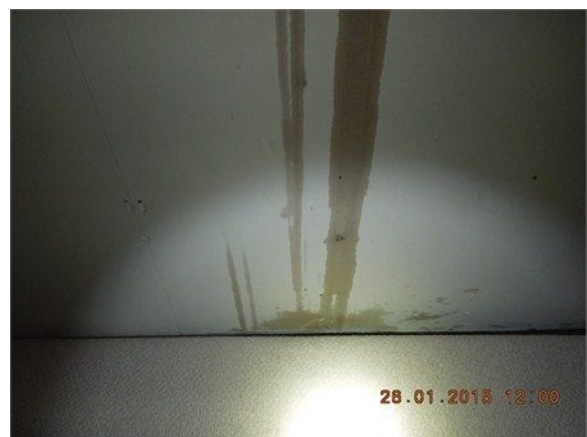
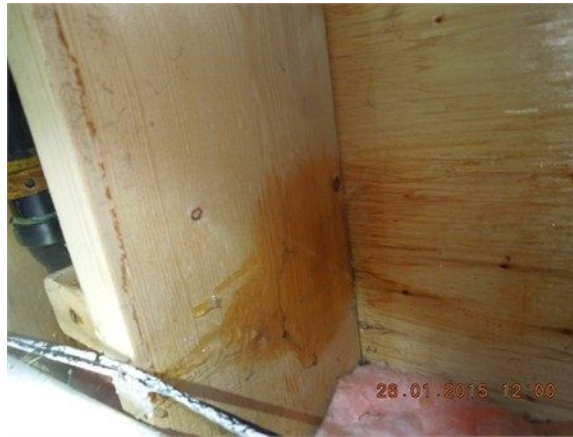
In order to avoid major deficiencies on this property we recommend you to consult a plumber to repair the leak in the supply pipes, meanwhile keep the water main water valve closed. We did note some repairs, maintenance work, and improvements that should be made, however, all of these elements are more fully presented in this report.

We detected a leak in the water supply system. In time, this leak could become worse and cause serious damage. The leak should be repaired by a professional. Clean, disinfect, and dry the material affected by the leak, and remove any signs of moulds and any spoiled material.

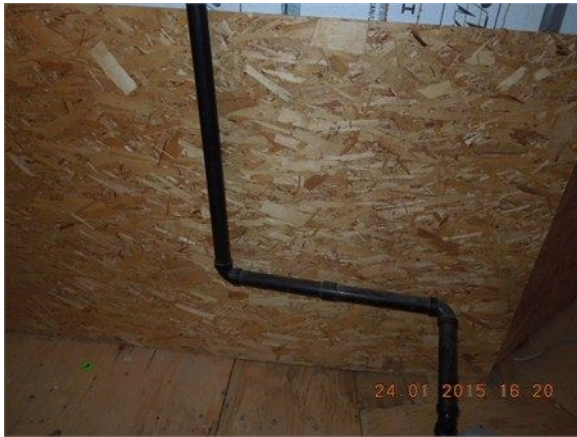
sump pump

We note that the waste water drainage system is secured with inadequate clamps and supports. Appropriate clamps and supports should be installed to avoid damage and/or obstruction due to a collapsed water line.

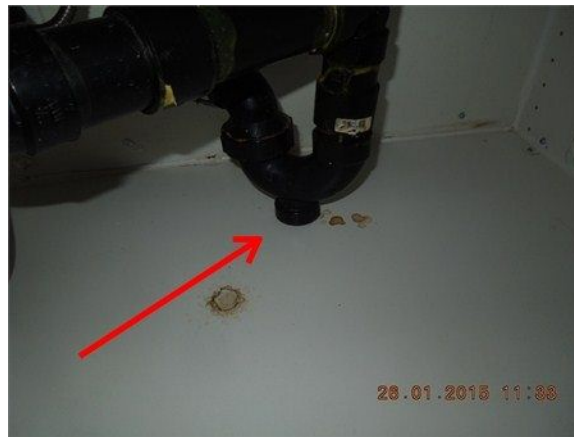
During our inspection we noticed that the installation of the "P" trap under the kitchen sink will prevent you from cleaning the trap. Consult a plumber to make the necessary correction.

not enough space

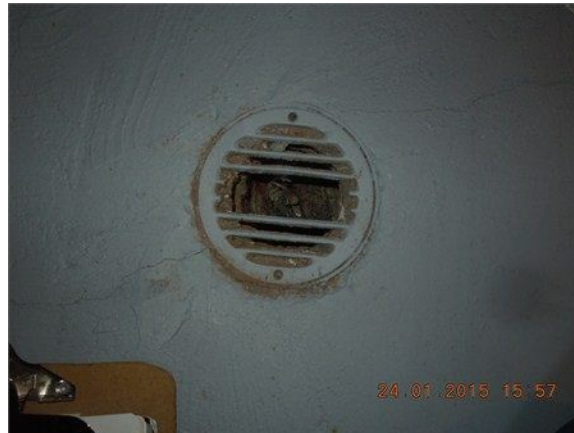
During our visit, we have noted that the floor drain was clogged and non-functional. Consult a competent plumber in order to unclog this component and ensure its proper drainage.

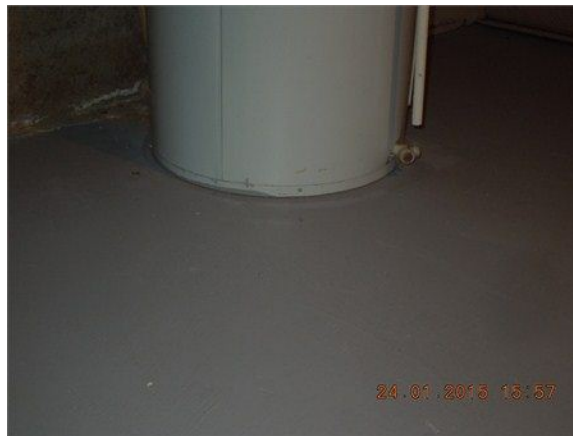
During our inspection we noted that the Domestic water heater is in direct contact with the ground. This can cause corrosion of the equipment's base and energy losses due to the freshness of the slab. We recommend that you install the equipment on blocks of wood.

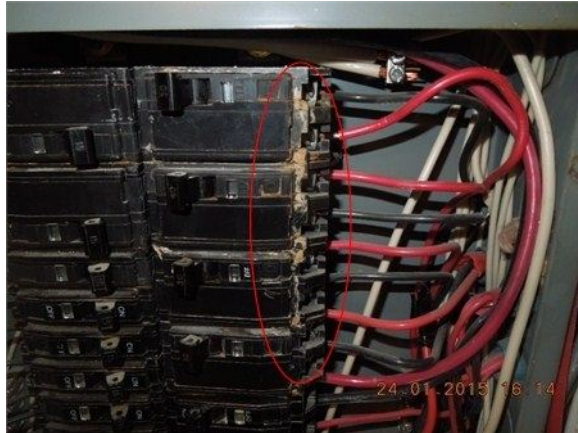
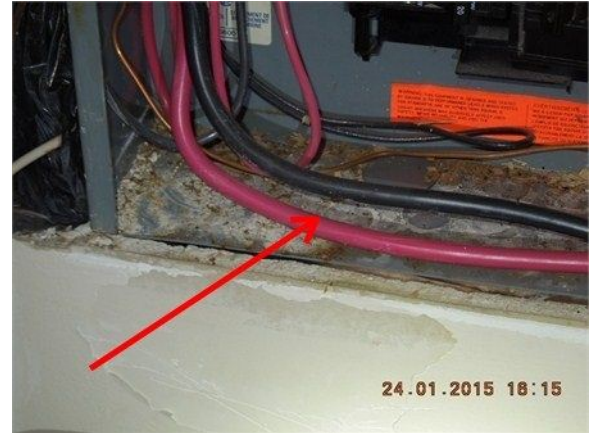
We observed water and/or rust spots inside the distribution panel. The panel is installed in a closet and temperature difference could cause condensation. Verify regularly the panel and if the problem persist an intervention would be needed

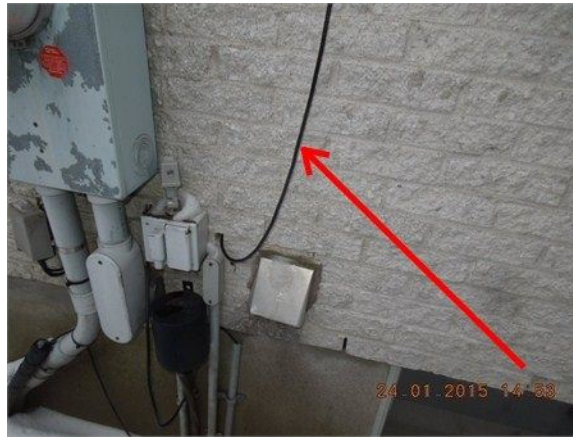
right side

We detected the presence of unconcealed electric wiring on the exterior of the building. This is not a recommended practice. We recommend that these circuits be rerouted inside the building or through exterior conduits that can provide adequate protection from water and humidity.

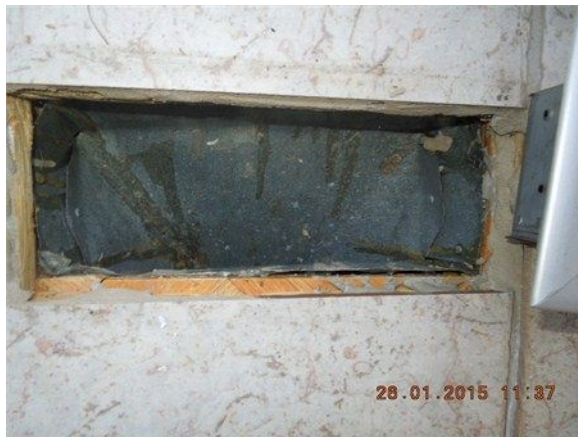
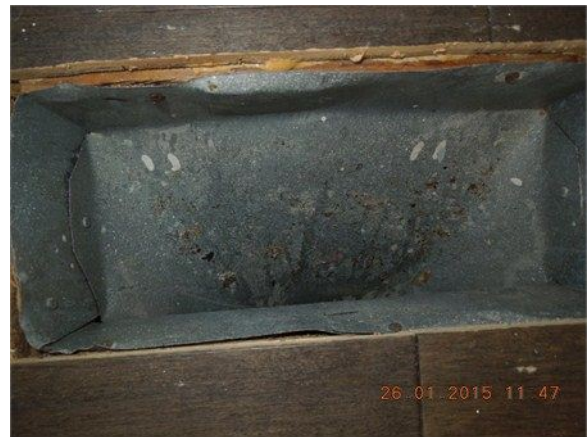
We note that dirt and dust have accumulated in the ventilation unit and forced air distribution system. Dirt and dust are transported by the air circulating through the system and may be dangerous to the health. All air ducts should be thoroughly cleaned. You should plan on inspecting and cleaning the system every five years. The air filter should be replaced regularly as recommended by the manufacturer.

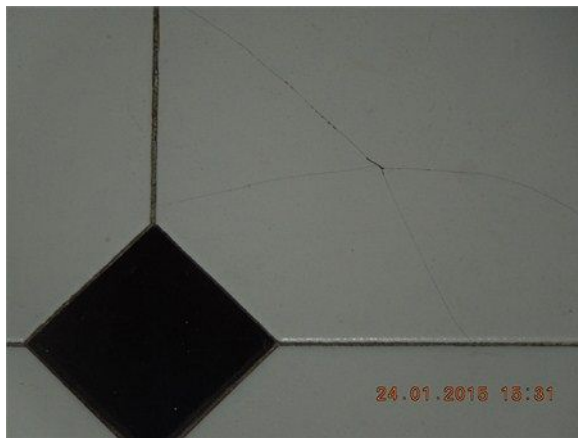
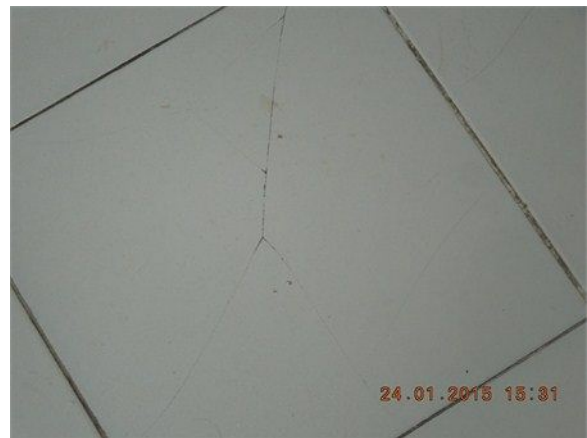
During our inspection, we noticed that the kitchen's ceramic is cracked the problem is cosmetic, if you are planning to remodel the kitchen it will be necessary to change the floor covering as well.

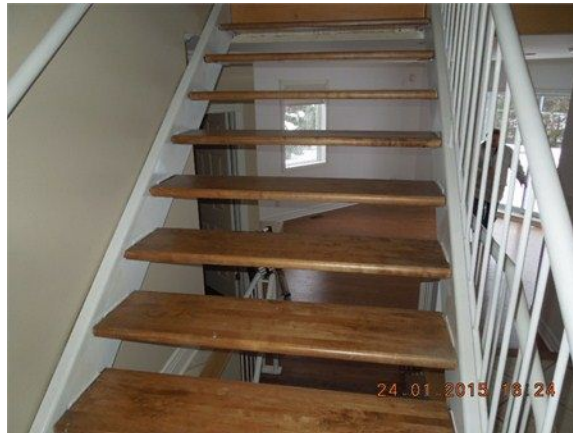
We observed a staircase with opened counter steps. This may represent a dangerous situation for young children. It would be preferable to install counter steps or partial counter steps.

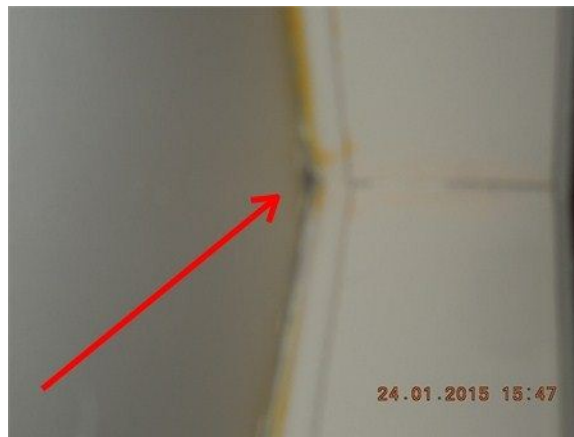
We note that the weather strip is ineffective on the door between the house and the garage. This could allow carbon monoxide gas to enter the house. This gas could be harmful to the health of the occupants of the house. An effective weather strip should be installed.

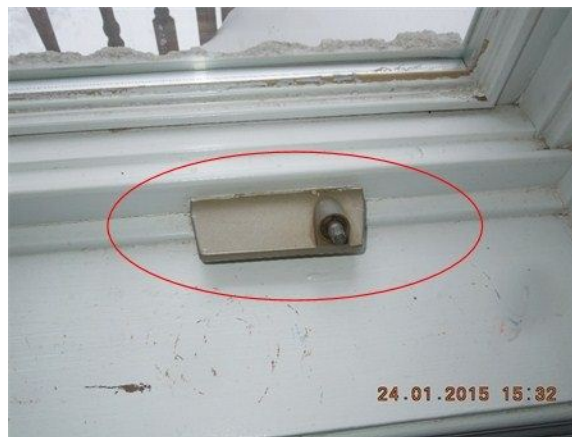
We have noted that the opening mechanism of certain windows was missing. Inspect each window, adjust the opening and replace the worn or damaged parts.

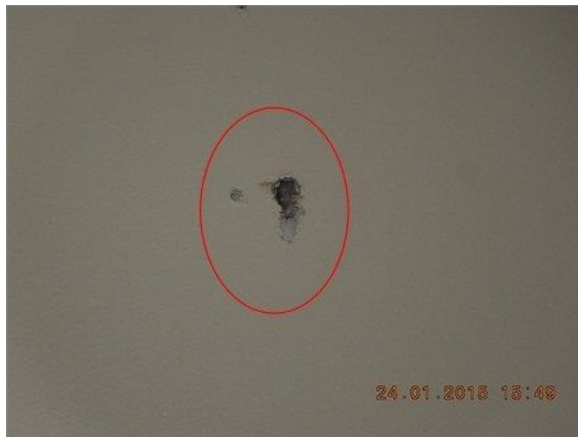
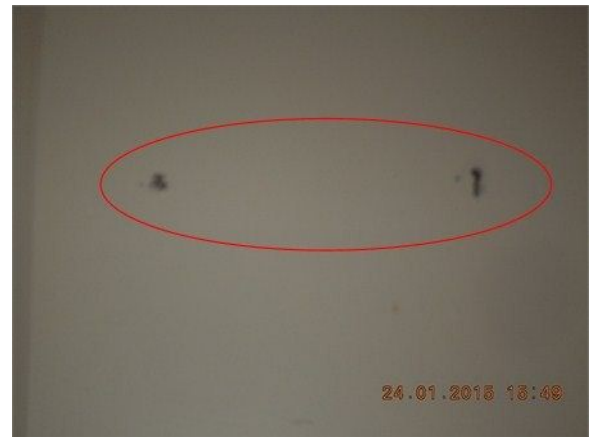
During our inspection, we noted the deficiency of the air barrier between the garage and the house this can cause leakage of carbon monoxide (CO), a colorless and odorless gas that can accumulate to lethal levels in confined spaces, without the knowledge of the occupants.

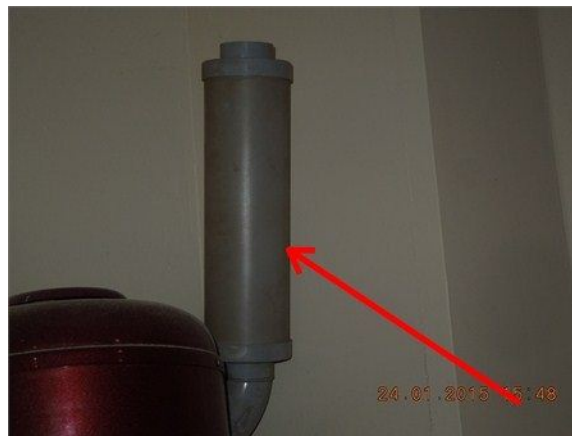
To improve the air quality and to eliminate, as much as possible, the amount of dust in suspension in the air, a central vacuum cleaner should vent its exhaust air outdoors. Ensure that the air is vented directly outdoors through a sealed conduit.

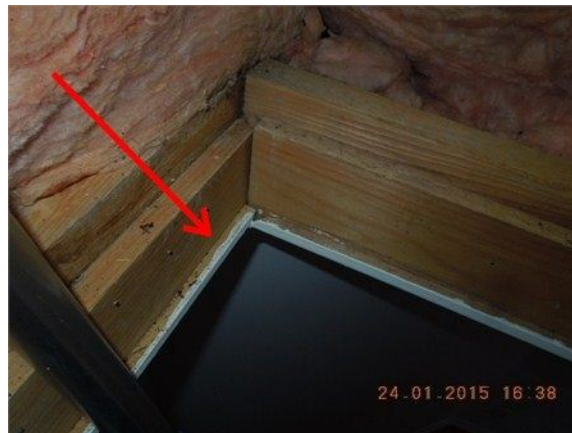
The attic space's access hatch would need a gasket (neoprene) on its perimeter and would benefit from being heavier so that the contact with the gasket be efficient.

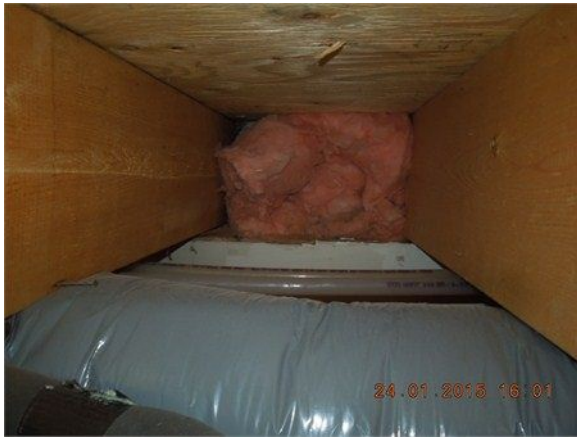
mechanical room

We noted the installation of wool batt insulation without a vapor barrier on the building's rim joist. This situation causes air infiltration in the house. Furthermore, interior humidity may cause condensation in the wool insulation, causing odors of mold and a deterioration of the rim joist, and of the wooden structured wall. To avoid this problem, a vapor barrier must be installed on the warm side of the insulation. (Polyethylene sealed all around).

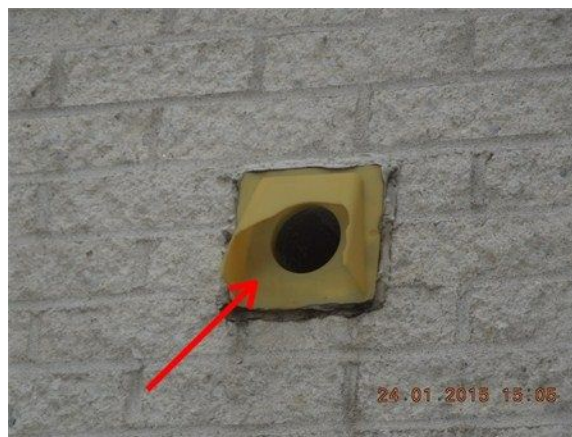
right side

We noted that the exterior dryer exhaust register was defective and possessed a cold air flow penetration. We recommend the installation of an anti-gust type exhaust register in order to properly evacuate the dryer's exhausting air.

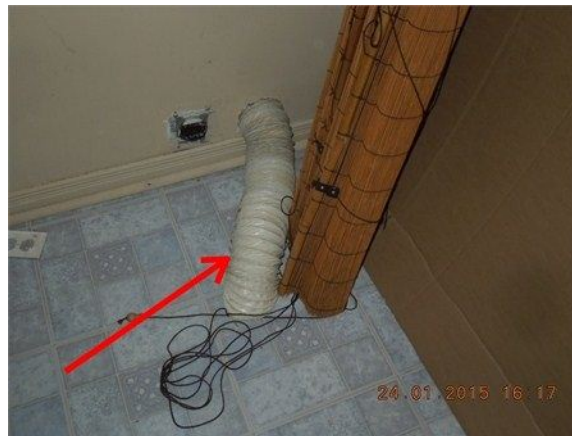
We noticed a combustible (plastic) duct on the dryer exhaust. We recommend replacing it with a galvanized duct. Rigid ducts offer less air resistance and do not accumulate as much debris. As much as possible, limit the number of elbows and the total length of the duct.
